**Flood Control Project Maintenance
Levee Inspections**
LMA District Cover Sheet
Spring 2017 Levee Inspection Results

Reclamation District No. 0349 Sutter Island

Spring 2017 Levee Inspection Results

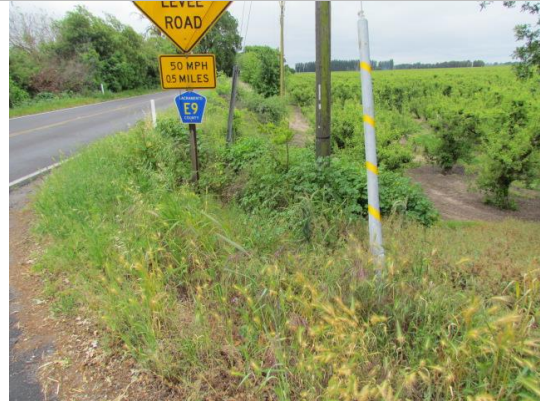
Photo 1 of 1 : SP_2017_RD0349_204_15_20170426_00024.jpg

LM Start	0.00	Rating **	U	Issue No.	15
LM End	0.99	Issue Type +	Ma	Location *	LS
Category	Earthen Levee			GPS Latitude/Longitude	
				Start	End
Item	Vegetation			38.327148 °	38.313078 °
				-121.576952 °	-121.578780 °
DWR ID	DWR_RD0349_01_f_2016_15				
Comment Code					
V1 : Control annual grass and weeds on the levee slopes and easements.					
Inspector Comment					
Control the wild growth of vegetation on the landside levee slope.

RD 349 Unit 1 levee mile 0.00 looking downstream landside slope.

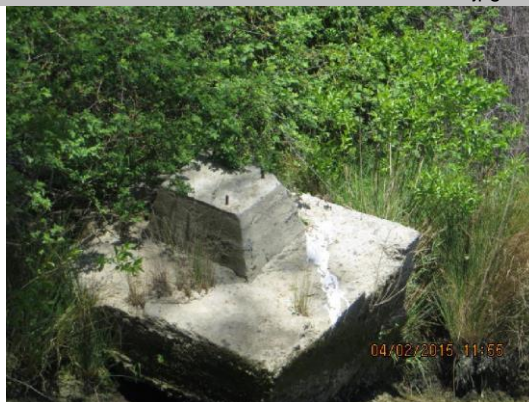
Photo 3 of 3 : UCIP_SP_2017_44303_73620.jpg

Comment Code						
Inspector Comment						
FS_ID:44303						
DS_ID:24137						
EP_NO: N/A						
Repair Type: Non-Urgent						
Crossing Status: Indicator Found						
UCIP Comments: Pipe appears to be abandoned and if so should be done so properly. Electromagnetic survey indicated a crossing at this location.						
FIELD_STRUCT_DESC: *ABANDONED* 10-inch pipe through the levee, 3.8 feet below the crown. Power pole and anchor on the landward side. Deteriorated concrete box at the LS toe. Concrete debris on WS toe good indicator of pump location (USACE-1960). This entry matches the Drainage or Irrigation Structure referenced in O&M manual (HLM 2.74).						
FS Date: 4/2/2015

Concrete debris on WS toe is a good indicator of pump location.

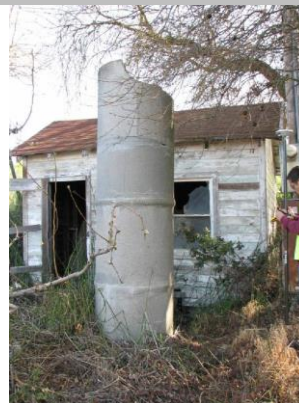
Photo 3 of 3 : UCIP_SP_2017_21572_36578.jpg

Comment Code					
Inspector Comment					
FS_ID:21572 DS_ID:24521 EP_NO: N/A Repair Type: Non-Urgent Crossing Status: Found UCIP Comments: No records were found during intial desk study--need to contact owner to obtain permit number authorizing work. If crossing is no longer used by owner, the owner will need to coordinate with DWR Inspector and CVFPB to remove crossing according to Title 23 requirements. Dense vegetation limits the inspector's visibility to identify signs of pipe failure (leaks) along the slope. Recommend removing vegetation along pipe alignment to conduct proper inspection of structure and appurtenances. Note date on photos should be 3/18/09 not 7/26/08 camera metadata is incorrect. FIELD_STRUCT_DESC: *ABANDONED* 8-inch pipe through the levee, 13.9 feet below the crown. Pump on platform at landward toe. Service pole on landward slope. FS Date: 3/18/2009

View of pump house, concrete stand pipe, and utility pole.

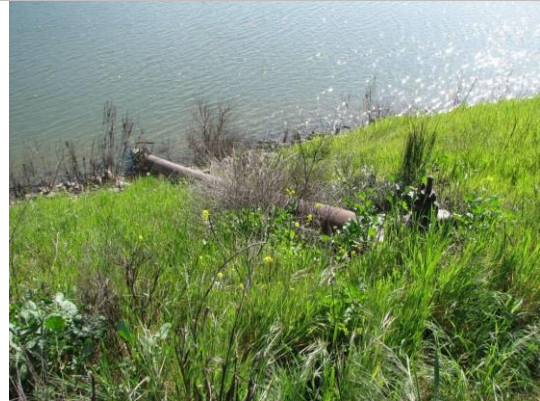
Photo 1 of 3 : UCIP_SP_2017_50013_36561.jpg

FS_ID:50013
DS_ID:24140
EP_NO: N/A
Repair Type: Non-Urgent
Crossing Status: Found
UCIP Comments: 8/22/2016 Crossing has been downgraded from Urgent to Non-Urgent no signs of pipe failure were visible during site inspection. Minor erosion visible on LS shoulder covered by dry leaves. No permit was found--need to contact owner to determine age of crossing and determine when the last internal inspection was completed. (DWR UCIP - omagana)8/13/2009 Exposed section of levee slope on LS--need to contact owner and DWR inspector. Dense vegetation limits the inspector's visibility to identify signs of pipe failure (leaks) along the slope. Recommend removing vegetation along pipe alignment to conduct proper inspection of structure and appurtenances. Note date on photos should be 3/18/09 not 7/26/08 camera metadata is incorrect. (DWR UCIP - omagana)
FIELD_STRUCT_DESC: 14-inch pipe (waterside (WS) shoulder) and 12-inch pipe (landside (LS) shoulder) through the levee, 4.7 feet below the crown. Gate valve on the WS slope. Pump in pumphouse on LS slope. Pressure breaker behind pumphouse. Pipe exposed on WS slope. [Additional Reference(s): DWR Levee Log, 2005. USACE San Joaquin O&M Manual Unit No. 110, May 1959, HLM 1.1]

View of pipe on WS.

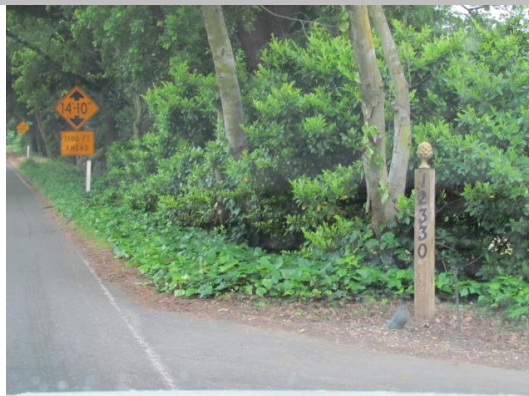
Photo 1 of 1 : SP_2017_RD0349_204_16_20170516_00027.jpg

LM Start	1.06	Rating **	U	Issue No.	16
LM End	1.24	Issue Type +	En	Location *	LS
Category	Earthen Levee			GPS Latitude/Longitude	
				Start	End
Item	Vegetation			38.311992 °	38.309635 °
				-121.578460 °	-121.577285 °
DWR ID	DWR_RD0349_01_f_2016_16				
Comment Code					
V6 : Landscaping					
Inspector Comment					
The landscaping along levee mile 1.06-1.24 is unmaintained and completely blocking the view of landside levee slope.

RF 349 Unit 1 levee mile 1.06-1.24.

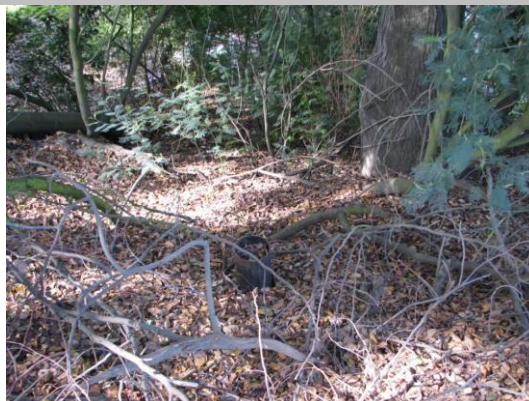
Photo 2 of 3 : UCIP_SP_2017_44214_36571.jpg

FS_ID:44214
DS_ID:24143
EP_NO: 12005
Repair Type: Non-Urgent
Crossing Status: Found
UCIP Comments: Pipe open on WS slope. 2007 Erosion Repair Site location?--Need to contact owner to determine if crossing is still in use. Dense vegetation limits the inspector's visibility to identify signs of pipe failure (leaks) along the slope. Recommend removing vegetation along pipe alignment to conduct proper inspection of structure and appurtenances. Note date on photos should be 3/18/09 not 7/26/08 camera metadata is incorrect.
FIELD_STRUCT_DESC: 6-inch steel irrigation pipe, 4.0 feet below the crown. Siphon breaker and protective housing at levee shoulder. Pump on waterward side. Pipe exposed on waterward slope, extending to pump. Discharge structure at landward toe. (Permit No. 12005-1977)
FS Date: 4/2/2015

Pipe located on landward side--unable to determine whether it belongs to crossing.

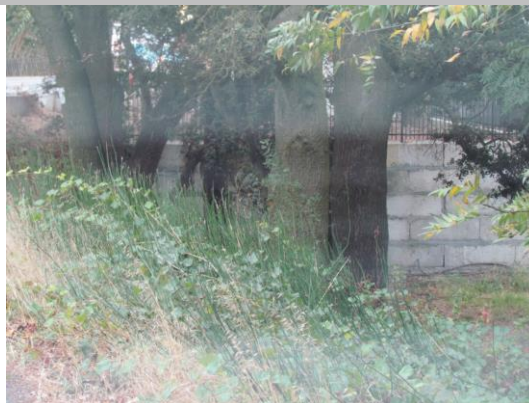
Photo 1 of 1 : SP_2017_RD0349_204_12_20170404_00001.jpg

LM Start	1.54	Rating **	U	Issue No.	12
LM End	1.54	Issue Type +	En	Location *	LS
Category	Earthen Levee			GPS Latitude/Longitude	
				Start	End
Item	Encroachments			38.305722 °	38.305722 °
				-121.574680 °	-121.574695 °
DWR ID	DWR_RD0349_01_f_2014_12				
Comment Code					
RW : Retaining Wall					
Inspector Comment					
This issue is under review with the CVFPB. No change.

Looking downstream at levee mile 1.55 unauthorized block wall placed on landward levee section, no CVFPB Permit.

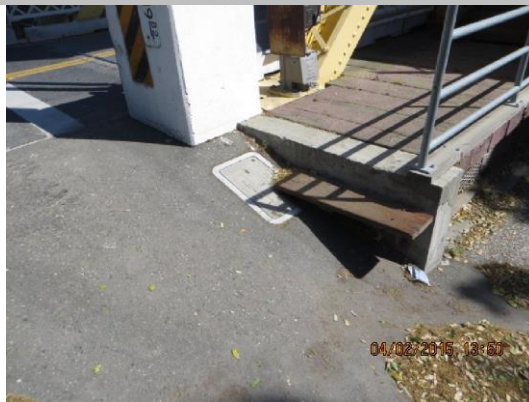
Photo 2 of 3 : UCIP_SP_2017_46168_74543.jpg

LM Start	0.00	Rating **	M	Issue No.	86
LM End	0.00	Issue Type +	En	Location *	LS
Category	Supplemental			GPS Latitude/Longitude	
				Start	End
Item	DWR UCIP Field Study			38.305124 °	38.305124 °
				-121.574772 °	-121.574772 °
DWR ID					
Comment Code					
Inspector Comment					
FS_ID:46168 DS_ID:25096 EP_NO: N/A Repair Type: Non-Urgent Crossing Status: Indicator Found UCIP Comments: Need to identify permit for crossing. FIELD_STRUCT_DESC: 2-inch waterline through the levee at an unknown depth below crown. Pipe provides service to bridge and beach (per landowner). FS Date: 4/9/2015

Christy box on WS shoulder.

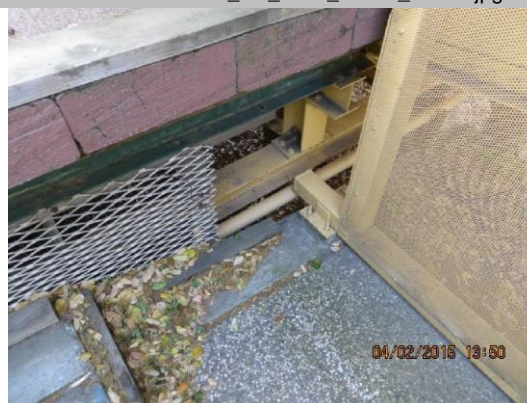
Photo 3 of 3 : UCIP_SP_2017_46168_74544.jpg

LM Start	0.00	Rating **	M	Issue No.	86 (cont)
LM End	0.00	Issue Type +	En	Location *	LS
Category	Supplemental			GPS Latitude/Longitude	
				Start	End
Item	DWR UCIP Field Study			38.305124 °	38.305124 °
				-121.574772 °	-121.574772 °
DWR ID					
Comment Code					
Inspector Comment					
FS_ID:46168 DS_ID:25096 EP_NO: N/A Repair Type: Non-Urgent Crossing Status: Indicator Found UCIP Comments: Need to identify permit for crossing. FIELD_STRUCT_DESC: 2-inch waterline through the levee at an unknown depth below crown. Pipe provides service to bridge and beach (per landowner). FS Date: 4/9/2015

Pipe visible next to bridge on WS shoulder.

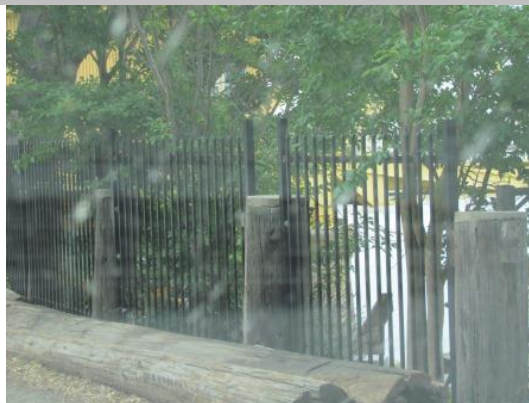
Photo 2 of 2 : SP_2017_RD0349_205_4_20170404_00007.jpg

LM Start	0.01	Rating **	U	Issue No.	4 (cont)	
LM End	0.01	Issue Type +	En	Location *	WS	
Category	Earthen Levee			GPS Latitude/Longitude		
				Start		End
Item	Encroachments			38.304870 °		38.304870 °
				121.574730 °		121.574730 °
DWR ID	DWR_RD0349_02_s_2012_4					
Comment Code						
BU : Building						
Inspector Comment						
This encroachment is along the waterward shoulder and was not authorized by the CVFPB. There are multiple encroachments at this site. Owner was working with CVFPB to get permits as of 11-2013. This issue is still pending as of 2016. No change. 5-2017.

Unauthorized fence adjacent to building waterside Sutter Slough.

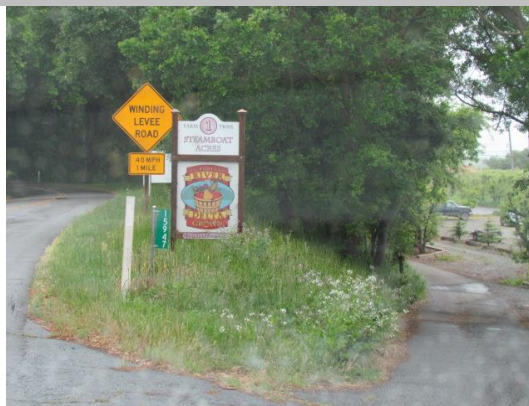
Photo 1 of 1 : SP_2017_RD0349_205_34_20170516_00082.jpg

LM Start	0.03	Rating **	U	Issue No.	34
LM End	1.31	Issue Type +	Ma	Location *	LS
Category	Earthen Levee			GPS Latitude/Longitude	
				Start	End
Item	Vegetation			38.304993 °	38.289043 °
				-121.575160 °	-121.584015 °
DWR ID	DWR_RD0349_02_f_2016_34				
Comment Code					
V1 : Control annual grass and weeds on the levee slopes and easements.					
Inspector Comment					
Control the annual grasses and weeds from the slope and berm.

RD 349 Unit 2 landside.

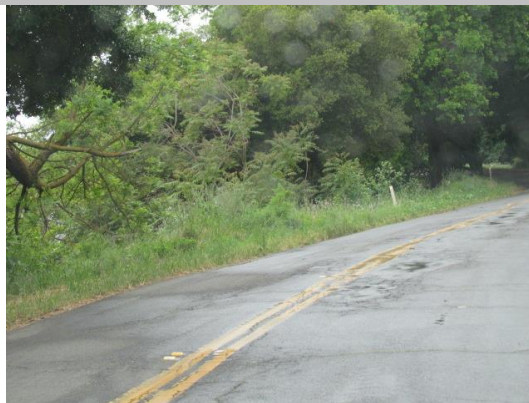
Photo 1 of 1 : SP_2017_RD0349_205_37_20170516_00083.jpg

LM Start	0.04	Rating **	U	Issue No.	37
LM End	0.52	Issue Type +	Ma	Location *	WS
Category	Earthen Levee			GPS Latitude/Longitude	
				Start	End
Item	Vegetation			38.304928 °	38.300007 °
				-121.575310 °	-121.581023 °
DWR ID	DWR_RD0349_02_s_2017_37				
Comment Code					
V1 : Control annual grass and weeds on the levee slopes and easements.					
Inspector Comment					
Spray and mow the waterside slope and shoulder.

RD 349 Unit 2 looking at the waterside slope and shoulder.

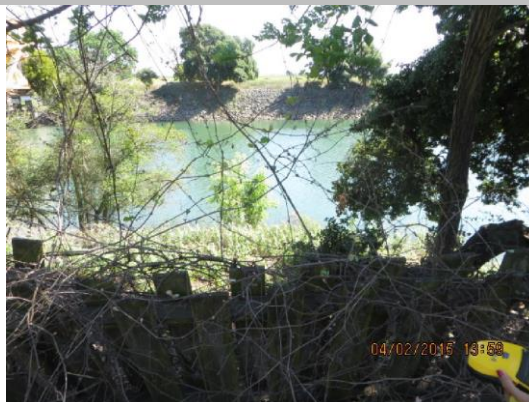
Photo 2 of 3 : UCIP_SP_2017_46169_74546.jpg

Fence on WS shoulder.

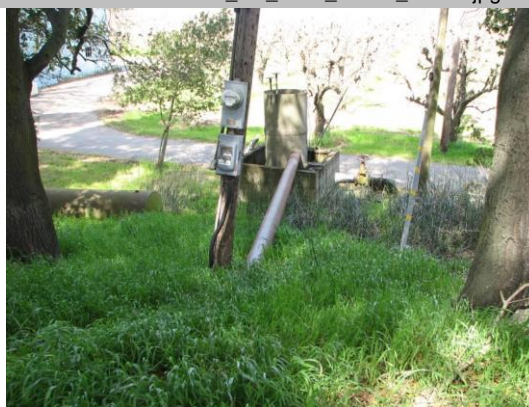
Photo 3 of 3 : UCIP_SP_2017_21576_36591.jpg

Multiple appurtenances found on landward side-standpipe, electrical pole, valve, concrete distribution box.

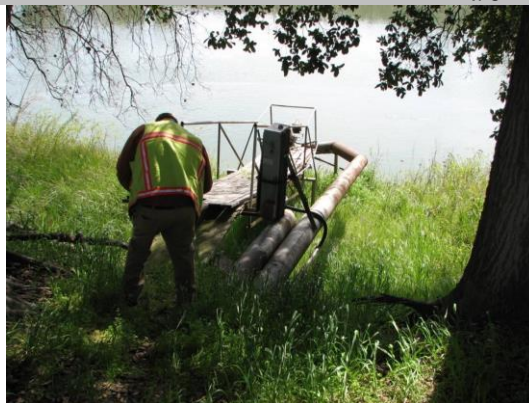
Photo 1 of 3 : UCIP_SP_2017_21577_36597.jpg

Dense vegetation on waterward slope-2 pipes and 1 conduit.

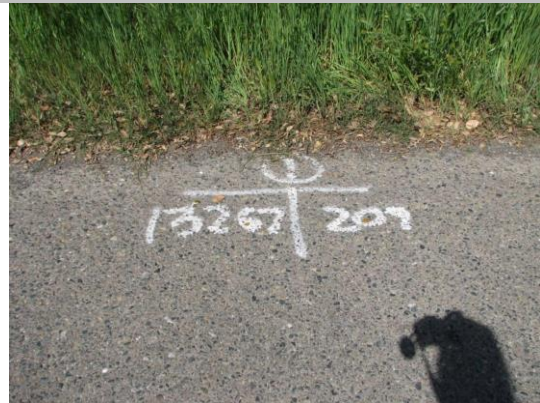
Photo 1 of 3 : UCIP_SP_2017_21613_36685.jpg

Comment Code					
Inspector Comment					
FS_ID:21613 DS_ID:24147 EP_NO: N/A Repair Type: Non-Urgent Crossing Status: Found UCIP Comments: Dense vegetation limits the inspector's visibility to identify signs of pipe failure (leaks) along the slope. Recommend removing vegetation along pipe alignment to conduct proper inspection of structure and appurtenances. Note date on photos should be 3/18/09 not 7/26/08 camera metadata is incorrect. FIELD_STRUCT_DESC: 3-inch pipe through the levee, 3.3 feet below the crown. Gate valve on landward side. (USACE-1959). This entry matches the Drainage or Irrigation Structure referenced in O&M manual (HLM 0.1). FS Date: 3/18/2009

Underground service alert (USA) marking on levee crown.

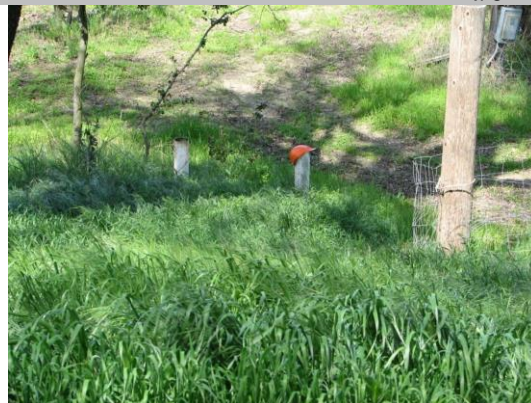
Photo 1 of 3 : UCIP_SP_2017_21614_36691.jpg

View of landward side--unable to inspect.

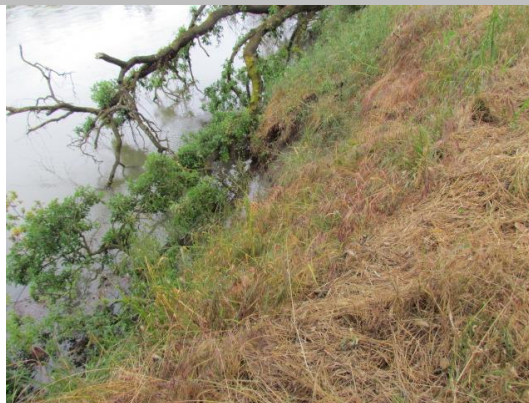
Photo 1 of 1 : SP_2017_RD0349_205_39_20170516_00086.jpg

LM Start	0.35	Rating **	U	Issue No.	39
LM End	0.35	Issue Type +	Ma	Location *	WS
Category	Earthen Levee			GPS Latitude/Longitude	
				Start	End
Item	Slope Stability			38.302368 °	38.302368 °
				-121.579933 °	-121.579933 °
DWR ID	DWR_RD0349_02_s_2017_39				
Comment Code					
S1 : Repair slope instability.					
Inspector Comment					
This erosion occurred during the Feb Storm 2017 event. This site need immediate attention,

RD 349 Unit 2 levee mile 0.35 waterside slope and shoulder.

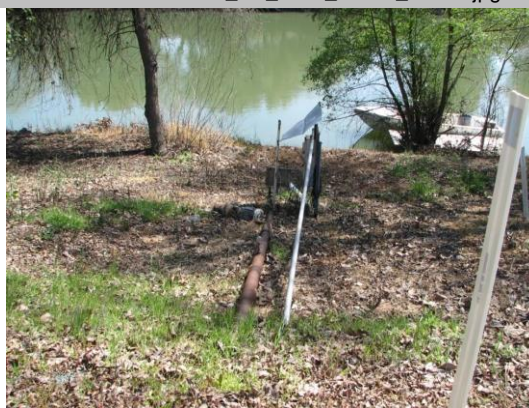
Photo 1 of 3 : UCIP_SP_2017_21615_36694.jpg

Comment Code					
Inspector Comment					
FS_ID:21615 DS_ID:24149 EP_NO: N/A Repair Type: Non-Urgent Crossing Status: Found UCIP Comments: Need to contact owner (Permit No. 3678) to determine if crossing is still in use. If crossing is not in use will need to coordinate with DWR Inspector and CVFPB to remove pipe according to Title 23 requirements. Note date on photos should be 3/18/09 not 7/26/08 camera metadata is incorrect. FIELD_STRUCT_DESC: 6-inch irrigation pipe through the levee, 2.5 feet below the crown. Pump on waterward slope. Service pole at landward shoulder. 3-inch conduite through levee to service pump. (USACE-1959). This entry matches the Drainage or Irrigation Structure referenced in O&M manual (HLM 0.6). Pump replaced and placed on concrete pad on waterward slope under Permit No. 3678 (1961). FS Date: 3/18/2009

View of pipe and pump on waterward side.

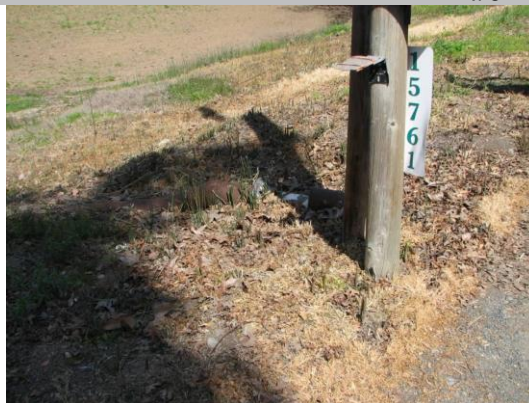
Photo 2 of 3 : UCIP_SP_2017_21615_36695.jpg

FS_ID:21615
DS_ID:24149
EP_NO: N/A
Repair Type: Non-Urgent
Crossing Status: Found
UCIP Comments: Need to contact owner (Permit No. 3678) to determine if crossing is still in use. If crossing is not in use will need to coordinate with DWR Inspector and CVFPB to remove pipe according to Title 23 requirements. Note date on photos should be 3/18/09 not 7/26/08 camera metadata is incorrect.
FIELD_STRUCT_DESC: 6-inch irrigation pipe through the levee, 2.5 feet below the crown. Pump on waterward slope. Service pole at landward shoulder. 3-inch conduit through levee to service pump. (USACE-1959). This entry matches the Drainage or Irrigation Structure referenced in O&M manual (HLM 0.6). Pump replaced and placed on concrete pad on waterward slope under Permit No. 3678 (1961).
FS Date: 3/18/2009

View of landward shoulder--service pole and pipe section through slope.

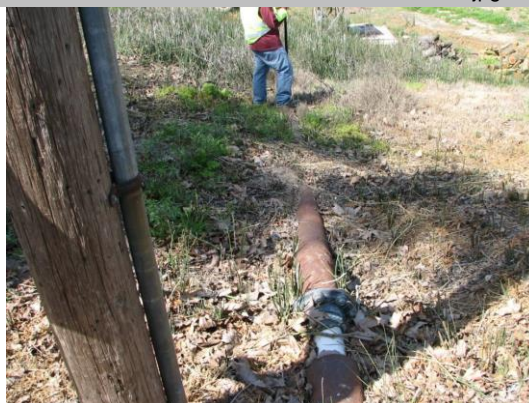
Photo 3 of 3 : UCIP_SP_2017_21615_36696.jpg

View of landward side--it appears PVC pipe was sleeved through existing crossing.

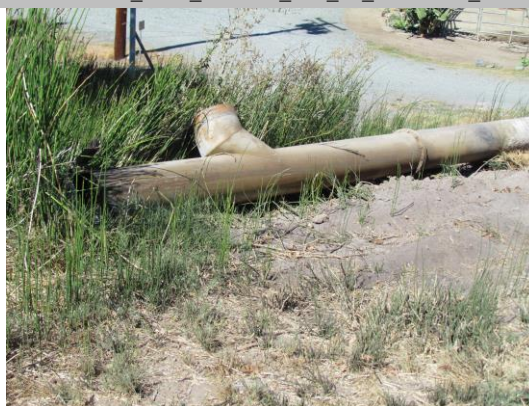
Photo 1 of 1 : SP_2017_RD0349_205_35_20170404_00015.jpg

LM Start	1.06	Rating **	M	Issue No.	35
LM End	1.06	Issue Type +	En	Location *	LS
Category	Earthen Levee			GPS Latitude/Longitude	
				Start	End
Item	Encroachments			38.292557 °	38.292557 °
				-121.583875 °	-121.583875 °
DWR ID	DWR_RD0349_02_f_2016_35				
Comment Code					
PI : Pipe					
Inspector Comment					
Old irrigation discarded pipe on landside slope need to be removed.

RD 349 Unit 2 levee mile 1.06 landside toe.

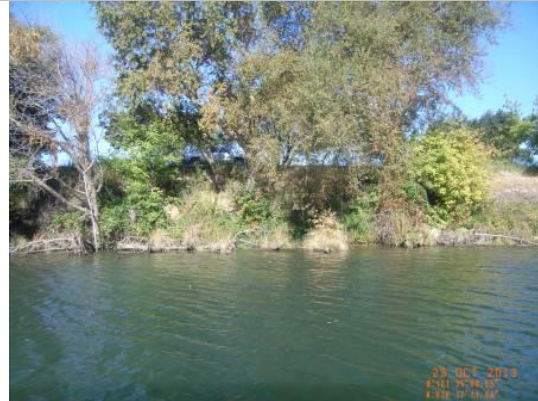
Photo 1 of 1 : SP_2017_RD0349_205_10_20170404_00009.jpg

Comment Code					
Inspector Comment					
1997 - Erosion of very sandy levee behind large stand of riparian vegetation on top right bank. Dry ravel of sand. 1999 - Quarry waste rock was dumped down the levee slope; poor repair job; still eroding in places. Eroding at midslope off fabric. 2005 - Length revised, only the middle 150 - 200 ft are eroding. 2006 - Some rock/small material dumped down the bank but it is slowly unraveling. Upstream end is unraveling faster. Steep slope with poor gradation so fines are washing out. 2010 - Lots of overhanging trees and erosion pockets. 2011 - This site is upgraded to CRITICAL. Near vertical bank at the downstream end. New erosion at various locations throughout the site. 2015: No observed changes. [2015 Site ID: STM_24-7_R]

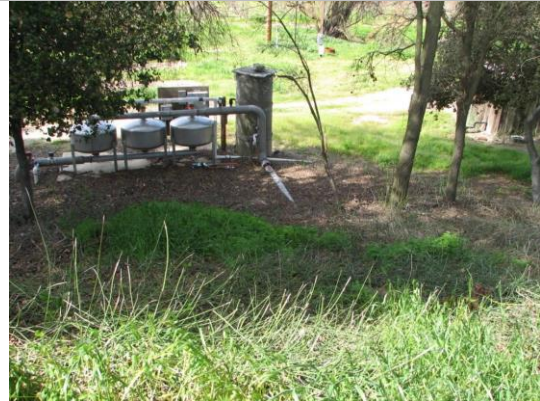
Photo 3 of 3 : UCIP_SP_2017_21607_36658.jpg

Comment Code					
Inspector Comment					
FS_ID:21607 DS_ID:24155 EP_NO: 1116 Repair Type: Non-Urgent Crossing Status: Found UCIP Comments: Dense vegetation limits the inspector's visibility to identify signs of pipe failure (leaks) along the landward slope. Recommend removing vegetation along pipe alignment to conduct proper inspection of structure and appurtenances. Note date on photos should be 3/18/09 not 7/26/08 camera metadata is incorrect. FIELD_STRUCT_DESC: 8-inch steel irrigation pipe through the levee, 4.7 feet below the crown. Two concrete cutoff walls under each shoulder. Pressure breaker in concrete riser at levee shoulder. Pump on waterward side. (USACE-1959). This entry matches the Drainage or Irrigation Structure referenced in O&M manual (HLM 1.7). Pipe reconstructed under Permit No. 1116 (1974). FS Date: 3/18/2009

Filter system, control panel, and stand pipe located at the landward toe.

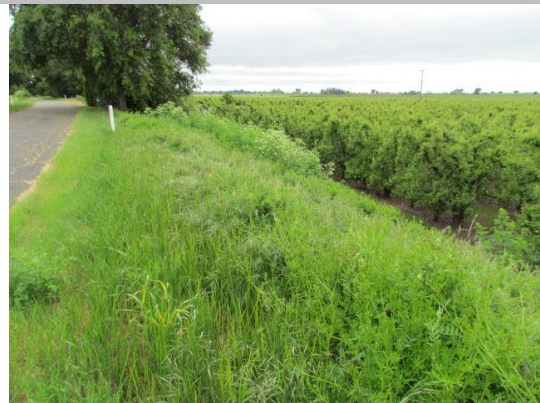
Photo 1 of 1 : SP_2017_RD0349_205_47_20170516_00088.jpg

LM Start	1.77	Rating **	U	Issue No.	47
LM End	4.30	Issue Type +	Ma	Location *	LS
Category	Earthen Levee			GPS Latitude/Longitude	
				Start	End
Item	Vegetation			38.284002 °	38.254703 °
				-121.588933 °	-121.599700 °
DWR ID	DWR_RD0349_02_s_2017_47				
Comment Code					
V2 : Remove the wild growth other than native grasses from the levee slopes.					
Inspector Comment					
Remove the wild growth other than native grasses from the landside levee slope.

RD 349 Unit 2 levee mile 1.77-3.79 landside slope and shoulder.

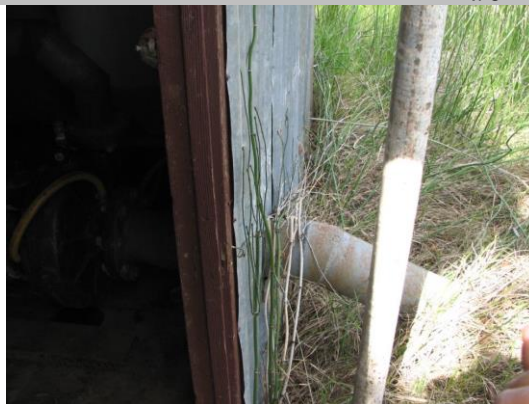
Photo 2 of 3 : UCIP_SP_2017_21608_36663.jpg

Comment Code					
Inspector Comment					
FS_ID:21608 DS_ID:24156 EP_NO: N/A Repair Type: Non-Urgent Crossing Status: Found UCIP Comments: Dense vegetation limits the inspector's visibility to identify signs of pipe failure (leaks) along the slope. Recommend removing vegetation along pipe alignment to conduct proper inspection of structure and appurtenances. Note date on photos should be 3/18/09 not 7/26/08 camera metadata is incorrect. FIELD_STRUCT_DESC: 10-inch pipe through the levee, 3.9 feet below the crown. Siphon breaker in concrete riser on the landward shoulder. Pump and gate valve in pumphouse on the waterward slope. (USACE-1959). This entry matches the Drainage or Irrigation Structure referenced in O&M manual (HLM 1.9). FS Date: 3/18/2009

View of pipe daylight at shed on waterward side.

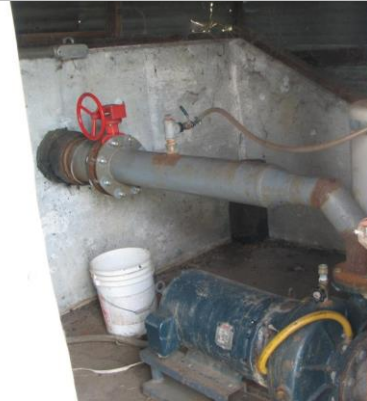
Photo 3 of 3 : UCIP_SP_2017_21608_36665.jpg

Comment Code						
Inspector Comment						
FS_ID:21608						
DS_ID:24156						
EP_NO: N/A						
Repair Type: Non-Urgent						
Crossing Status: Found						
UCIP Comments: Dense vegetation limits the inspector's visibility to identify signs of pipe failure (leaks) along the slope. Recommend removing vegetation along pipe alignment to conduct proper inspection of structure and appurtenances. Note date on photos should be 3/18/09 not 7/26/08 camera metadata is incorrect.						
FIELD_STRUCT_DESC: 10-inch pipe through the levee, 3.9 feet below the crown. Siphon breaker in concrete riser on the landward shoulder. Pump and gate valve in pumphouse on the waterward slope. (USACE-1959). This entry matches the Drainage or Irrigation Structure referenced in O&M manual (HLM 1.9).						
FS Date: 3/18/2009

View inside pump house of pipe crossing coming out of levee.

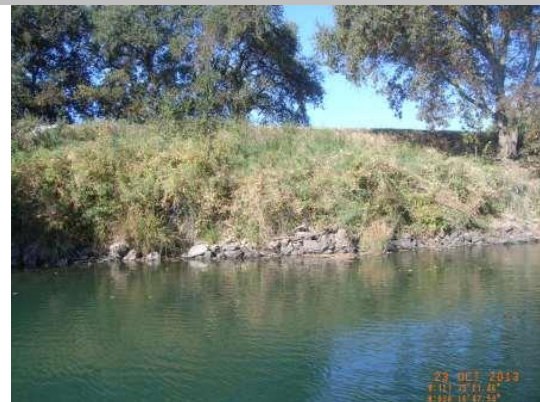
Photo 1 of 1 : SP_2017_RD0349_205_19_20170404_00013.jpg

LM Start	2.04	Rating **	M	Issue No.	19
LM End	2.05	Issue Type +	Ma	Location *	WS
Category	Supplemental			GPS Latitude/Longitude	
				Start	End
Item	2015 USACE Erosion Survey, DRAFT			38.280069 °	38.279919 °
				-121.589443 °	-121.589438 °
DWR ID	DWR_RD0349_02_s_2016_19				
Comment Code					
Inspector Comment					
2011 - Small scallop caused by erosion and wave wash. 2015: No observed changes. [2015 Site ID: STM_24-1_R]

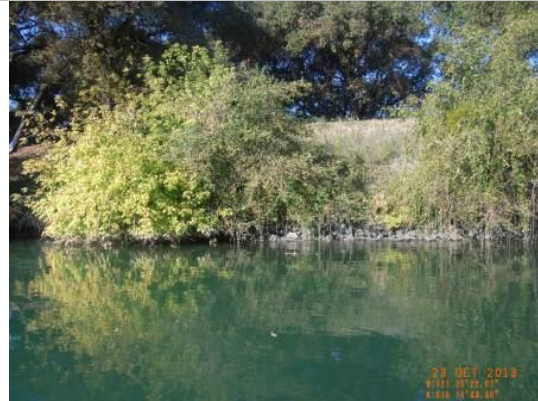
Photo 1 of 1 : SP_2017_RD0349_205_16_20170404_00012.jpg

LM Start	2.11	Rating **	M	Issue No.	16
LM End	2.14	Issue Type +	Ma	Location *	WS
Category	Supplemental			GPS Latitude/Longitude	
				Start	End
Item	2015 USACE Erosion Survey, DRAFT			38.279017 °	38.278597 °
				-121.589615 °	-121.589854 °
DWR ID	DWR_RD0349_02_s_2016_16				
Comment Code					
Inspector Comment					
1997 - Top right bank has retreated into the levee. Site is between two rock sites. 1999 - Downstream half of the reach repaired with rock. 2000 - Trees leaning into the water. 2010 - Site appears worse. 2011 - New erosion at the toe. 2013 - Short vertical sections observed at upstream end. 2015: Minor new erosion. [2015 Site ID: STM_23-9_R]

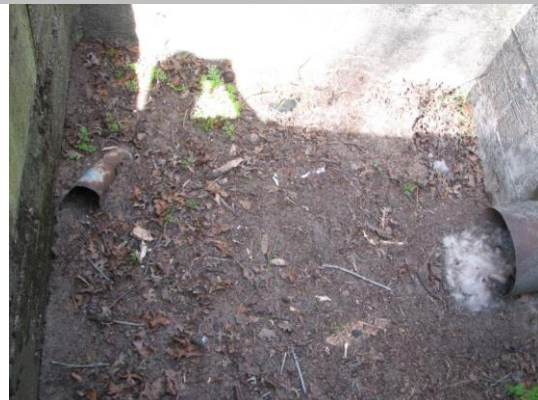
Photo 1 of 3 : UCIP_SP_2017_21609_36668.jpg

Comment Code					
Inspector Comment					
FS_ID:21609 DS_ID:24157 EP_NO: N/A Repair Type: Non-Urgent Crossing Status: Found UCIP Comments: Debris scattered--need to contact owner. If crossing is not in used will need to coordinate with DWR Inspector and CVFPB to remove per Title 23 requirements. Dense vegetation limits the inspector's visibility to identify signs of pipe failure (leaks) along the slope. Recommend removing vegetation along pipe alignment to conduct proper inspection of structure and appurtenances. Note date on photos should be 3/18/09 not 7/26/08 camera metadata is incorrect. FIELD_STRUCT_DESC: 8-inch pipe sleeved through 12-inch pipe through the levee, 4.0 feet below the crown. Annular gap not grouted. Service pole on the waterward shoulder. Pump on the waterward side. Concrete distribution box at landward toe. (USACE-1959). This entry matches the Drainage or Irrigation Structure referenced in O&M manual (HLM 2.3). FS Date: 3/18/2009

Inside view of distribution box located on landward side.

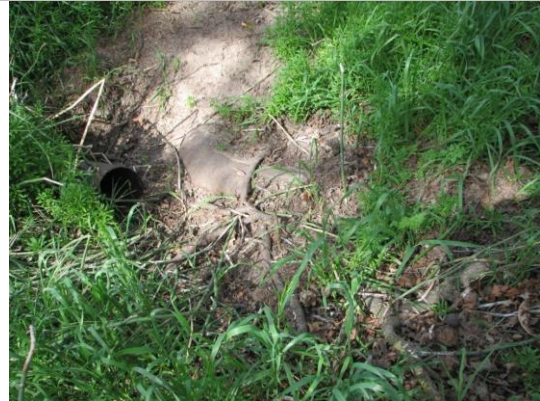
Photo 2 of 3 : UCIP_SP_2017_21609_36667.jpg

FS_ID:21609
DS_ID:24157
EP_NO: N/A
Repair Type: Non-Urgent
Crossing Status: Found
UCIP Comments: Debris scattered--need to contact owner. If crossing is not in use will need to coordinate with DWR Inspector and CVFPB to remove per Title 23 requirements. Dense vegetation limits the inspector's visibility to identify signs of pipe failure (leaks) along the slope. Recommend removing vegetation along pipe alignment to conduct proper inspection of structure and appurtenances. Note date on photos should be 3/18/09 not 7/26/08 camera metadata is incorrect.
FIELD_STRUCT_DESC: 8-inch pipe sleeved through 12-inch pipe through the levee, 4.0 feet below the crown. Annular gap not grouted. Service pole on the waterward shoulder. Pump on the waterward side. Concrete distribution box at landward toe. (USACE-1959). This entry matches the Drainage or Irrigation Structure referenced in O&M manual (HLM 2.3).
FS Date: 3/18/2009

Debris along pipe alignment.

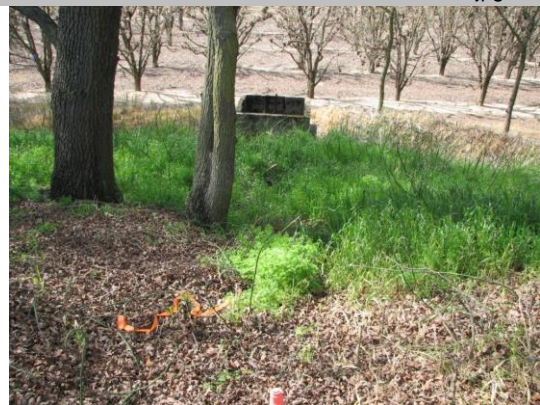
Photo 3 of 3 : UCIP_SP_2017_21609_36666.jpg

Overview of landward side--distribution box located at toe.

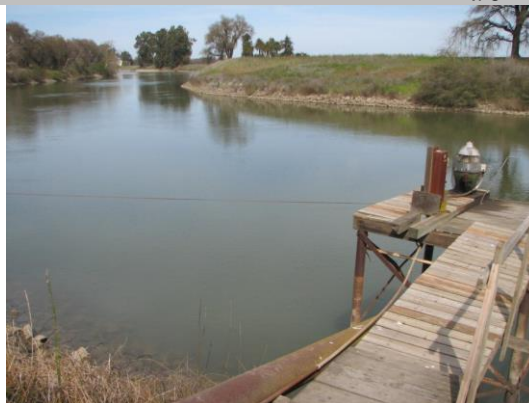
Photo 1 of 3 : UCIP_SP_2017_39873_36678.jpg

Comment Code					
Inspector Comment					
FS_ID:39873					
DS_ID:24158					
EP_NO: N/A					
Repair Type: Non-Urgent					
Crossing Status: Found					
UCIP Comments: Dense vegetation limit the inspector's visibility to identify signs of pipe failure (leaks) through the levee slopes. Recommend removing vegetation along pipe alignment to conduct proper inspection of structure and appurtenances.					
FIELD_STRUCT_DESC: 12-inch pipe through the levee, 4.0 feet below the crown. Pump on pile structure on waterward side, walkway to pump. Concrete distribution box and power pole with anchor at landward toe. Concrete standpipe on landward side. (Permit No. 946, 1944). This entry matches the Drainage or Irrigation Structure referenced in O&M manual (HLM 2.5).					
FS Date: 3/18/2009

View of waterward side--pump and control panel located on raised platform.

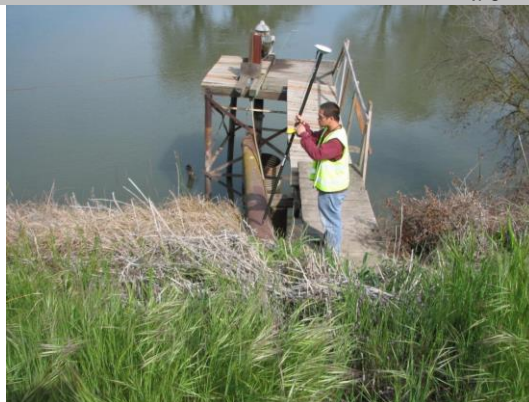
Photo 2 of 3 : UCIP_SP_2017_39873_36676.jpg

Overview of waterward side--dense vegetation limits slope inspection.

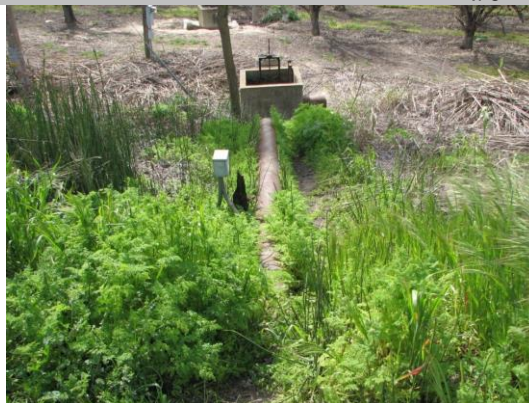
Photo 3 of 3 : UCIP_SP_2017_39873_36673.jpg

Comment Code					
Inspector Comment					
FS_ID:39873					
DS_ID:24158					
EP_NO: N/A					
Repair Type: Non-Urgent					
Crossing Status: Found					
UCIP Comments: Dense vegetation limit the inspector's visibility to identify signs of pipe failure (leaks) through the levee slopes. Recommend removing vegetation along pipe alignment to conduct proper inspection of structure and appurtenances.					
FIELD_STRUCT_DESC: 12-inch pipe through the levee, 4.0 feet below the crown. Pump on pile structure on waterward side, walkway to pump. Concrete distribution box and power pole with anchor at landward toe. Concrete standpipe on landward side. (Permit No. 946, 1944). This entry matches the Drainage or Irrigation Structure referenced in O&M manual (HLM 2.5).					
FS Date: 3/18/2009

View of landward side--2 distribution boxes are located along pipe alignment.

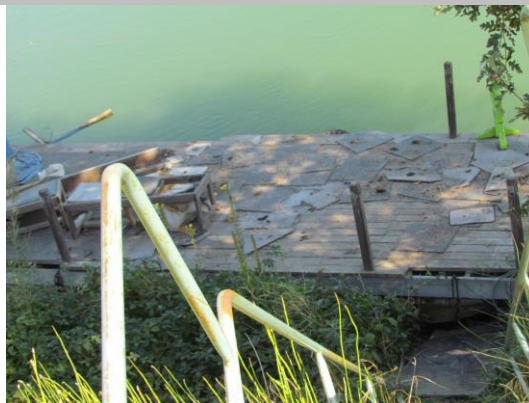
Photo 2 of 3 : SP_2017_RD0349_205_1_20170404_00002.jpg

LM Start	2.39	Rating **	U	Issue No.	1 (cont)	
LM End	2.39	Issue Type +	En	Location *	WS	
Category	Earthen Levee			GPS Latitude/Longitude		
				Start		End
Item	Encroachments			38.275403 °		38.275403 °
				-121.591229 °		-121.591229 °
DWR ID	DWR_RD0349_02_f_2013_1					
Comment Code						
ST : Stairway						
Inspector Comment						
The landowner has installed steps on the waterside slope and has an unauthorized boat dock anchored to the waterside slope.

Unauthorized dock at waterside toe.

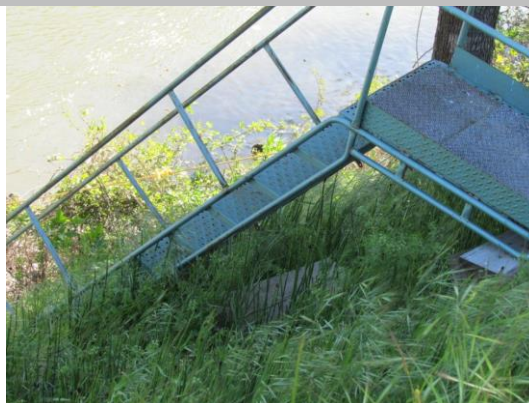
Photo 3 of 3 : SP_2017_RD0349_205_1_20170404_00003.jpg

Unauthorized metal steps on the waterside slope levee mile 2.39.

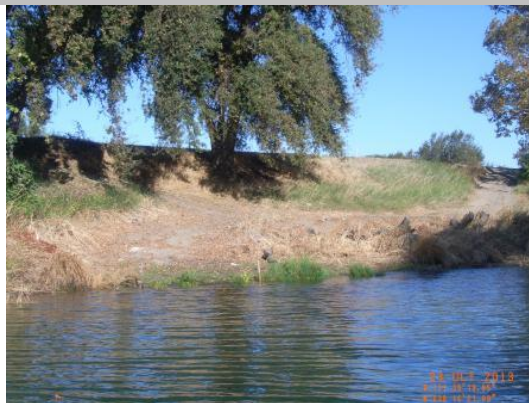
Photo 2 of 2 : SP_2017_RD0349_205_3_20170404_00005.jpg

LM Start	2.56	Rating **	M	Issue No.	3 (cont)	
LM End	2.69	Issue Type +	Ma	Location *	WS	
Category	Supplemental			GPS Latitude/Longitude		
				Start		End
Item	2015 USACE Erosion Survey, DRAFT			38.273854 °	38.271998 °	
				-121.588745 °	-121.589424 °	
DWR ID	DWR_RD0349_02_s_2016_3					
Comment Code						
Inspector Comment						
2011 - Toe scour at the tidal zone. 2015: New tree popout and minor new erosion. [2015 Site ID: STM_23-6_R]

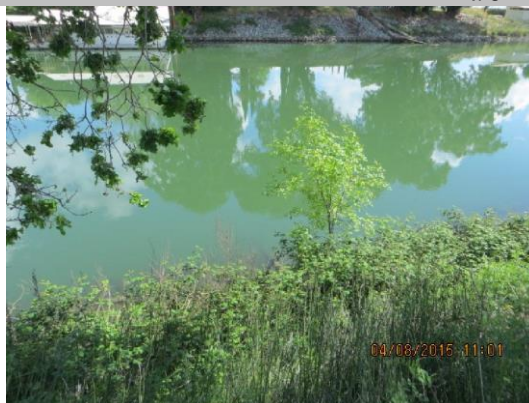
Photo 1 of 3 : UCIP_SP_2017_44328_73707.jpg

LM Start	2.93	Rating **	M	Issue No.	98
LM End	2.93	Issue Type +	En	Location *	WS
Category	Supplemental			GPS Latitude/Longitude	
				Start	End
Item	DWR UCIP Field Study			38.268674 °	38.268674 °
				-121.589419 °	-121.589419 °
DWR ID					
Comment Code					
Inspector Comment					
FS_ID:44328					
DS_ID:24159					
EP_NO: N/A					
Repair Type: Non-Urgent					
Crossing Status: Found					
UCIP Comments: Pipe appears abandoned and should be done so properly.					
FIELD_STRUCT_DESC: *ABANDONED* 6-inch pipe through the levee, 1.5 feet below the crown. (USACE-1959). This entry matches the Drainage or Irrigation Structure referenced in O&M manual (HLM 3.1).					
FS Date: 4/8/2015

Pipe visible in water at WS toe.

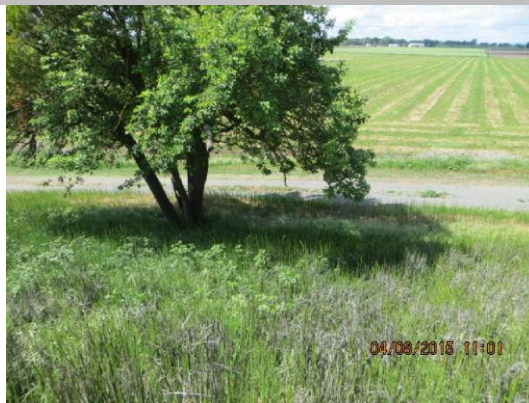
Photo 3 of 3 : UCIP_SP_2017_44328_73705.jpg

LM Start	2.93	Rating **	M	Issue No.	98 (cont)	
LM End	2.93	Issue Type +	En	Location *	WS	
Category	Supplemental			GPS Latitude/Longitude		
				Start	End	
Item	DWR UCIP Field Study			38.268674 °	38.268674 °	
				-121.589419 °	-121.589419 °	
DWR ID						
Comment Code						
Inspector Comment						
FS_ID:44328						
DS_ID:24159						
EP_NO: N/A						
Repair Type: Non-Urgent						
Crossing Status: Found						
UCIP Comments: Pipe appears abandoned and should be done so properly.						
FIELD_STRUCT_DESC: *ABANDONED* 6-inch pipe through the levee, 1.5 feet below the crown. (USACE-1959). This entry matches the Drainage or Irrigation Structure referenced in O&M manual (HLM 3.1).						
FS Date: 4/8/2015

No pipe visible on LS toe.

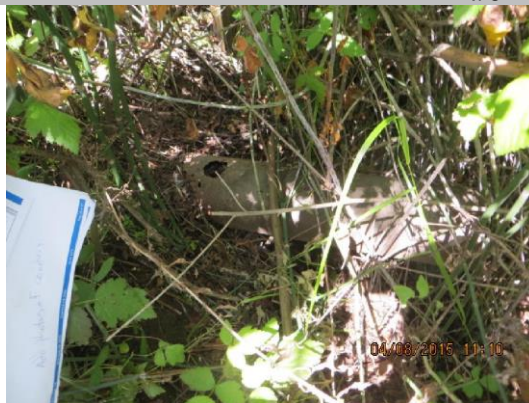
Photo 2 of 3 : UCIP_SP_2017_50015_73708.jpg

Comment Code					
Inspector Comment					
FS_ID:50015 DS_ID:24160 EP_NO: 655 Repair Type: Urgent Crossing Status: Found UCIP Comments: 8/17/2016 Dense vegetation limits the inspector's visibility to inspect levee section along pipe alignment. Previous inspection indicates holes visible on pipe wall. Need to contact owner to notify that pipe needs to be abandoned properly per Title 23 requirements. (DWR UCIP - omagana)4/8/2015 Pipe visible on WS slope and appears to be open. Pipe needs to be properly abandoned or verified as having been done so properly. (DWR UCIP - omagana) FIELD_STRUCT_DESC: *ABANDONED* 6-inch steel pipe through the levee, 3.7 feet below the crown. Pump on concrete blocks on the waterside (WS) slope. 2-inch galvanized conduit is buried along side of the 6-inch pipe. PG&E service was installed on the landside (LS). (6-inch pipe authorized under Permit No. 5350, 1966 - Enver Salman, 6-inch pipe replaced previous 8-inch pipe authorized under Permit No. 655, 1935 - M. S. Salman) Unable to confirm if 8-inch pipe is the same pipe listed in the USACE O&M manual as HLM 3.2. [Additional Reference(s): DWR Levee Log, 2005. USACE San Joaquin O&M Manual Unit No. 110, May 1959, HLM 3.2, Drawing No. 50-4-3042]. FS Date: 8/17/2016

LM Start	3.02	Rating **	U	Issue No.	99 (cont)
LM End	3.02	Issue Type +	En	Location *	LS

Abandoned pipe visible on slope in vegetation behind new pipe on WS slope.

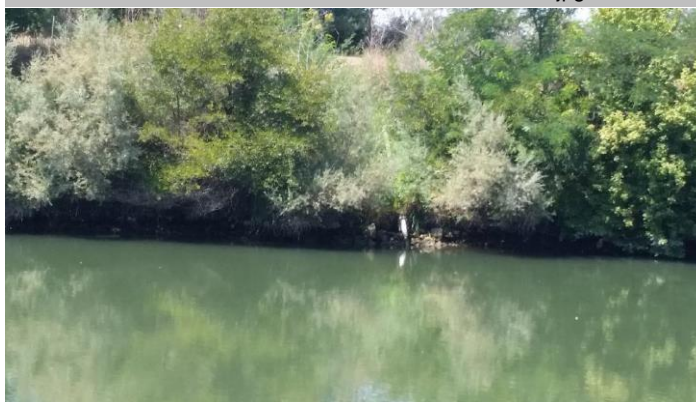
Photo 3 of 3 : UCIP_SP_2017_50015_75632.jpg

Pipe visible from opposite bank.

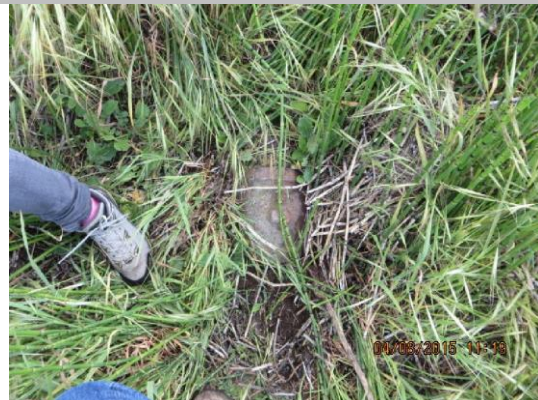
Photo 1 of 3 : UCIP_SP_2017_46172_74553.jpg

LM Start	3.15	Rating **	M	Issue No.	101
LM End	3.15	Issue Type +	En	Location *	LS
Category	Supplemental			GPS Latitude/Longitude	
				Start	End
Item	DWR UCIP Field Study			38.265608 °	38.265608 °
				-121.588391 °	-121.588391 °
DWR ID					
Comment Code					
Inspector Comment					
FS_ID:46172 DS_ID:25099 EP_NO: N/A Repair Type: Non-Urgent Crossing Status: Found UCIP Comments: Appears abandoned and if so should be verified as having been done so properly. FIELD_STRUCT_DESC: *ABANDONED* 6-inch pipe through the levee, 4.5 feet below the crown. Service pole at landward toe. FS Date: 4/2/2015

Pipe just visible on LS slope.

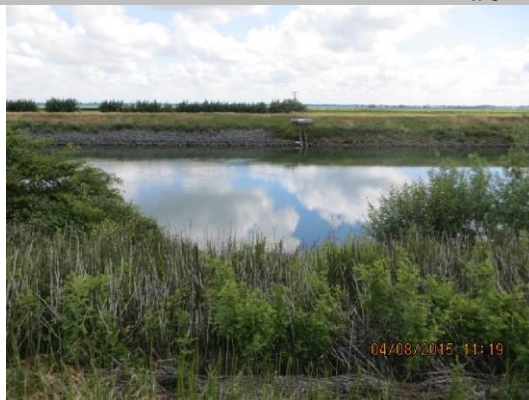
Photo 2 of 3 : UCIP_SP_2017_46172_74554.jpg

LM Start	3.15	Rating **	M	Issue No.	101 (cont)
LM End	3.15	Issue Type +	En	Location *	LS
Category	Supplemental			GPS Latitude/Longitude	
				Start	End
Item	DWR UCIP Field Study			38.265608 °	38.265608 °
				-121.588391 °	-121.588391 °
DWR ID					
Comment Code					
Inspector Comment					
FS_ID:46172 DS_ID:25099 EP_NO: N/A Repair Type: Non-Urgent Crossing Status: Found UCIP Comments: Appears abandoned and if so should be verified as having been done so properly. FIELD_STRUCT_DESC: *ABANDONED* 6-inch pipe through the levee, 4.5 feet below the crown. Service pole at landward toe. FS Date: 4/2/2015

View of WS from shoulder at crossing. Pipe not found on WS.

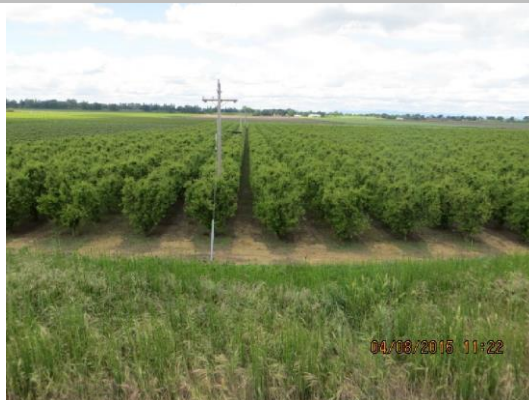
Photo 3 of 3 : UCIP_SP_2017_46172_74555.jpg

LM Start	3.15	Rating **	M	Issue No.	101 (cont)
LM End	3.15	Issue Type +	En	Location *	LS

Approximate pipe alignment on LS.

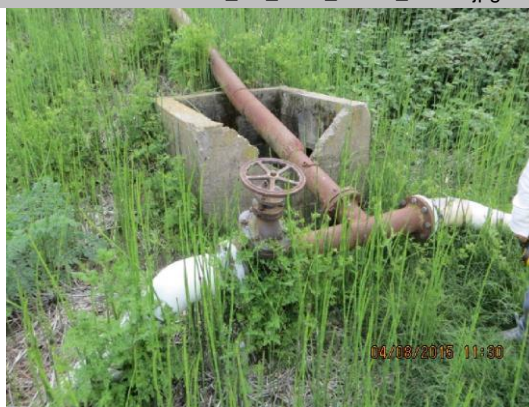
Photo 2 of 3 : UCIP_SP_2017_44333_73712.jpg

distribution box and pipe visible on LS toe.

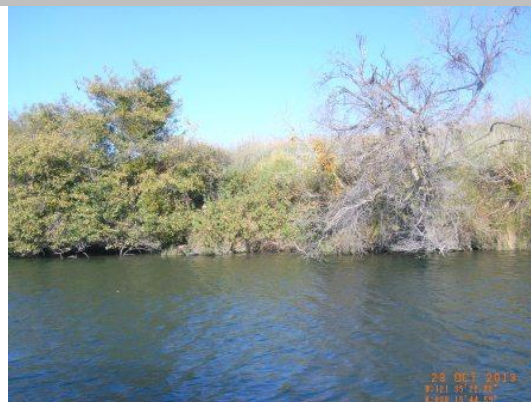
Photo 1 of 1 : SP_2017_RD0349_205_11_20170404_00010.jpg

LM Start	3.38	Rating **	M	Issue No.	11
LM End	3.49	Issue Type +	Ma	Location *	WS
Category	Supplemental			GPS Latitude/Longitude	
				Start	End
Item	2015 USACE Erosion Survey, DRAFT			38.262510 °	38.262533 °
				-121.589481 °	-121.591690 °
DWR ID	DWR_RD0349_02_s_2016_11				
Comment Code					
Inspector Comment					
2010 - Slumping sections on the lower bank, appears to be scouring around the trees. 2011 - Soil beach at toe. 2015: No observed changes. [2015 Site ID: STM_22-8_R]

USACE 2013 Photo #1

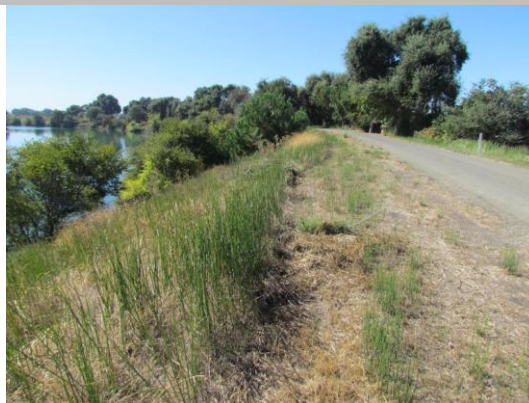
Photo 1 of 1 : SP_2017_RD0349_205_84_20170404_00027.jpg

LM Start	3.58	Rating **	U	Issue No.	84
LM End	4.31	Issue Type +	Ma	Location *	WS
Category	Earthen Levee			GPS Latitude/Longitude	
				Start	End
Item	Vegetation			38.262588 °	38.254733 °
				-121.593328 °	-121.599963 °
DWR ID	DWR_RD0349_02_f_2015_84				
Comment Code					
V2 : Remove the wild growth other than native grasses from the levee slopes.					
Inspector Comment					
Remove the snap grasses from the waterside levee slope.

Tall snap grasses covering the waterward slope. No change.

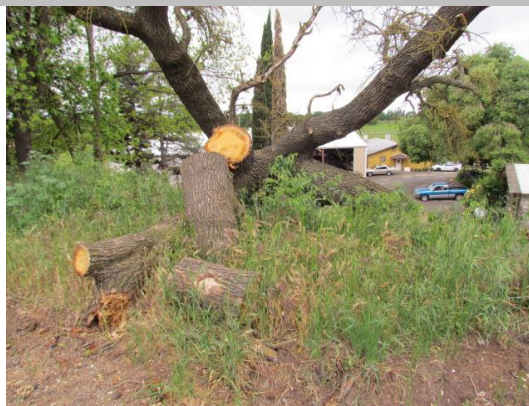
Photo 1 of 2 : SP_2017_RD0349_205_50_20170516_00089.jpg

LM Start	3.69	Rating **	U	Issue No.	50
LM End	3.69	Issue Type +	En	Location *	LS
Category	Earthen Levee			GPS Latitude/Longitude	
				Start	End
Item	Encroachments			38.261578 °	38.261578 °
				-121.594820 °	-121.594820 °
DWR ID	DWR_RD0349_02_s_2017_50				
Comment Code					
TR : Tree or limb					
Inspector Comment					
Remove the fallen tree from the levee slope and remove the cut up fire wood from the shoulder landward.

Landside slope levee mile 3.69.

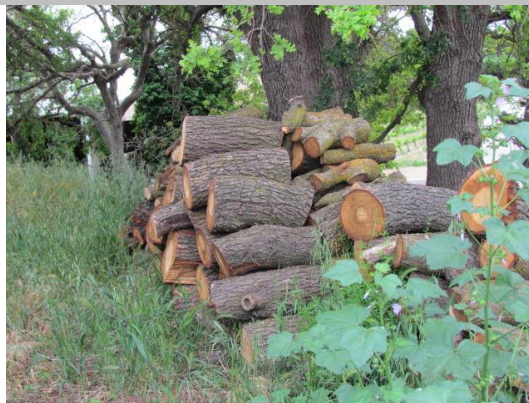
Photo 2 of 2 : SP_2017_RD0349_205_50_20170516_00091.jpg

LM Start	3.69	Rating **	U	Issue No.	50 (cont)
LM End	3.69	Issue Type +	En	Location *	LS

Landside shoulder and slope levee mile 3.69.

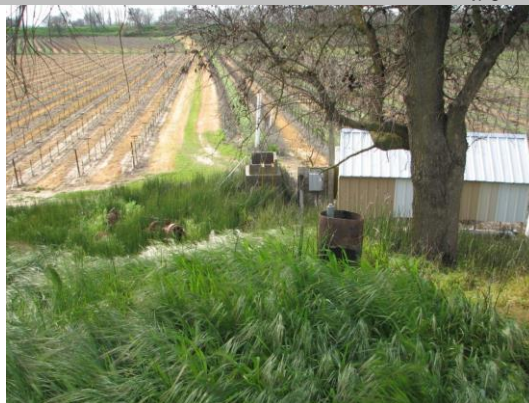
Photo 3 of 3 : UCIP_SP_2017_21612_36683.jpg

Item	DWR UCIP Field Study			38.260007 °	38.260007 °	
				-121.595273 °	-121.595273 °	
DWR ID						
Comment Code						
Inspector Comment						
FS_ID:21612 DS_ID:24162 EP_NO: 8188 Repair Type: Non-Urgent Crossing Status: Found UCIP Comments: Dense vegetation limits the inspector's visibility to identify signs of pipe failure (leaks) along the landward slope. Recommend removing vegetation along pipe alignment to conduct proper inspection of structure and appurtenances. Unable to determine if crossing is in use. Note date on photos should be 3/18/09 not 7/26/08 camera metadata is incorrect. FIELD_STRUCT_DESC: 12-inch steel irrigation pipe and 1.25-inch electrical conduit through the levee, both 5.0 feet below the crown. Steel cutoff wall around pipe at center of levee. Siphon breaker on shoulder. Pump and pumphouse on the waterward side. Service pole, discharge box and concrete standpipe at landward toe. (Permit No. 8188-1973) FS Date: 3/18/2009

Overview of lanward side--appurtenances include distribution box, stand pipe, pump house, and control panel.

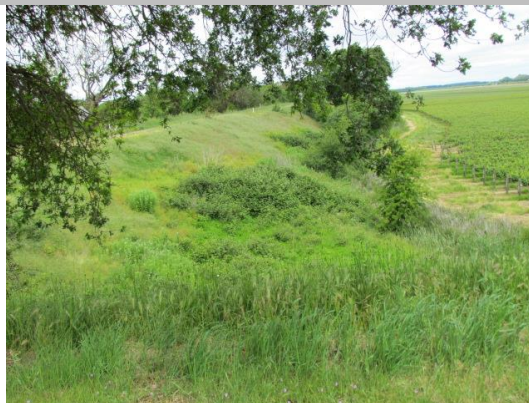
Photo 1 of 1 : SP_2017_RD0349_206_34_20170522_00078.jpg

LM Start	0.00	Rating **	U	Issue No.	34
LM End	1.52	Issue Type +	Ma	Location *	LS
Category	Earthen Levee			GPS Latitude/Longitude	
				Start	End
Item	Vegetation			38.254752 °	38.275993 °
				-121.600067 °	-121.601013 °
DWR ID	DWR_RD0349_03_f_2016_34				
Comment Code					
V2 : Remove the wild growth other than native grasses from the levee slopes.					
Inspector Comment					
Tall weeds on the landside levee slope need to be removed from the levee section.

RD 349 Unit 4 levee mile 0.00 landside slope and shoulder.

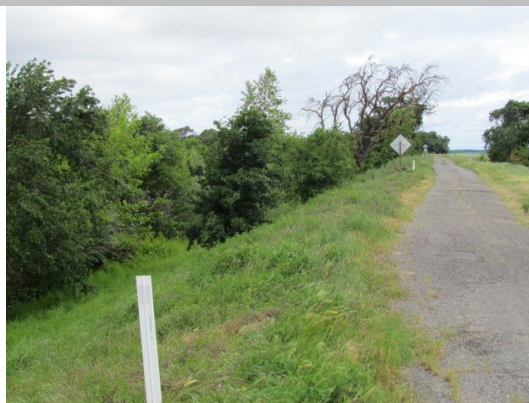
Photo 1 of 1 : SP_2017_RD0349_206_35_20170522_00079.jpg

LM Start	0.00	Rating **	U	Issue No.	35
LM End	2.74	Issue Type +	Ma	Location *	WS
Category	Earthen Levee			GPS Latitude/Longitude	
				Start	End
Item	Vegetation			38.254752 °	38.292205 °
				-121.600067 °	-121.603727 °
DWR ID	DWR_RD0349_03_f_2016_35				
Comment Code					
V1 : Control annual grass and weeds on the levee slopes and easements.					
Inspector Comment					
Tall weeds on the waterside levee slope need to be removed.

RD 349 Unit 4 levee mile 0.00 waterside slope.

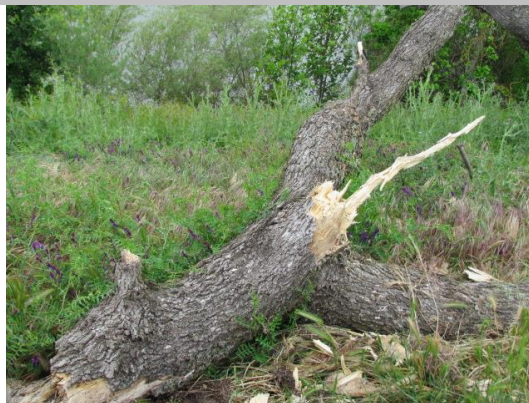
Photo 1 of 1 : SP_2017_RD0349_206_37_20170522_00077.jpg

LM Start	0.04	Rating **	U	Issue No.	37
LM End	0.04	Issue Type +	Ma	Location *	WS
Category	Earthen Levee			GPS Latitude/Longitude	
				Start	End
Item	Encroachments			38.255327 °	38.255327 °
				-121.600033 °	-121.600033 °
DWR ID	DWR_RD0349_03_f_2016_37				
Comment Code					
TR : Tree or limb					
Inspector Comment					
Dead tree on the waterside slope (large). This tree will fall and block access to the levee crown roadway. Remove the dead tree from the levee section.

RD 349 Unit 4 levee mile 0.04 Dead tree on the waterside shoulder and crown roadway.

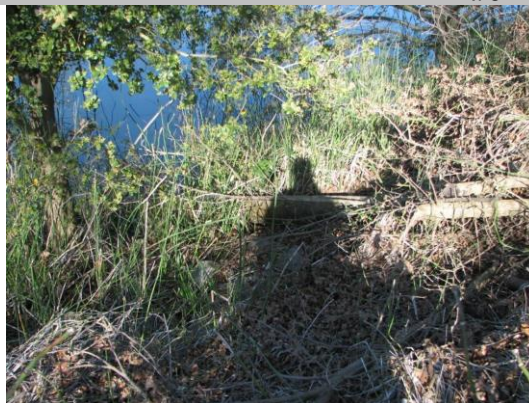
Photo 1 of 3 : UCIP_SP_2017_43442_36707.jpg

Comment Code					
Inspector Comment					
FS_ID:43442					
DS_ID:24163					
EP_NO: N/A					
Repair Type: Non-Urgent					
Crossing Status: Found					
UCIP Comments: Need to find owner and notify of pipe deterioration.					
Owner will need to replace or remove per CVFPB Title 23 requirements.					
Dense vegetation limits the inspector's visibility to identify signs of pipe					
failure (leaks) through the levee slopes. Recommend removing					
vegetation along pipe alignment to conduct proper inspection of					
structure and appurtenances. Note date on photos should be 3/18/09					
not 7/26/08 camera metadata is incorrect.					
FIELD_STRUCT_DESC: 8-inch steel irrigation pipe through the levee,

2.4 feet below the crown. Pump and gate valve in a pumphouse at the					
landward toe. Concrete standpipe on landward side.					
FS Date: 3/19/2009

View of waterward side--portion of pipe exposed on slope.

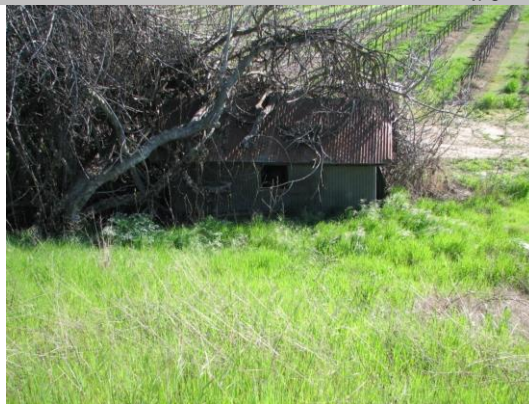
Photo 2 of 3 : UCIP_SP_2017_43442_36706.jpg

LM Start	0.77	Rating **	M	Issue No.	91 (cont)
LM End	0.77	Issue Type +	En	Location *	LS

Pump house located at the landward toe.

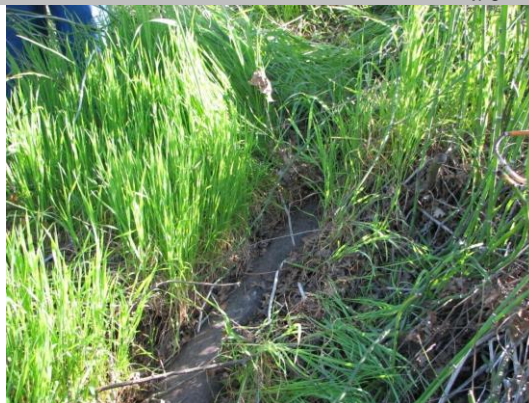
Photo 3 of 3 : UCIP_SP_2017_43442_36704.jpg

Comment Code					
Inspector Comment					
FS_ID:43442 DS_ID:24163 EP_NO: N/A Repair Type: Non-Urgent Crossing Status: Found UCIP Comments: Need to find owner and notify of pipe deterioration. Owner will need to replace or remove per CVFPB Title 23 requirements. Dense vegetation limits the inspector's visibility to identify signs of pipe failure (leaks) through the levee slopes. Recommend removing vegetation along pipe alignment to conduct proper inspection of structure and appurtenances. Note date on photos should be 3/18/09 not 7/26/08 camera metadata is incorrect. FIELD_STRUCT_DESC: 8-inch steel irrigation pipe through the levee, 2.4 feet below the crown. Pump and gate valve in a pumphouse at the landward toe. Concrete standpipe on landward side. FS Date: 3/19/2009

Pipe covered by dense vegetation.

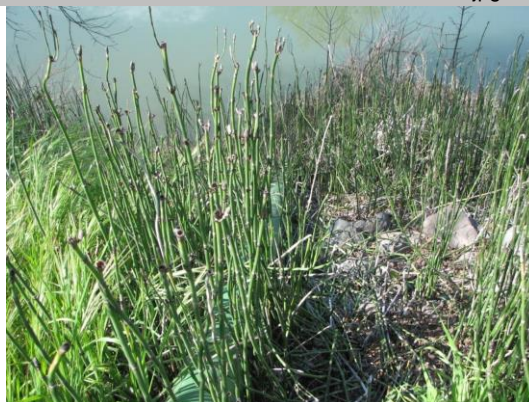
Photo 2 of 3 : UCIP_SP_2017_21673_36853.jpg

View of pipe crossing past pump station.
